Fire Risk Assessment

Property Owner: MCC
Date: 19/12/2023
Assessor: Stephen Brennan, TechIOSH, GIFireE,
AIFSM, DipFD

Address: Lamport Court
Manchester
M1 7EG

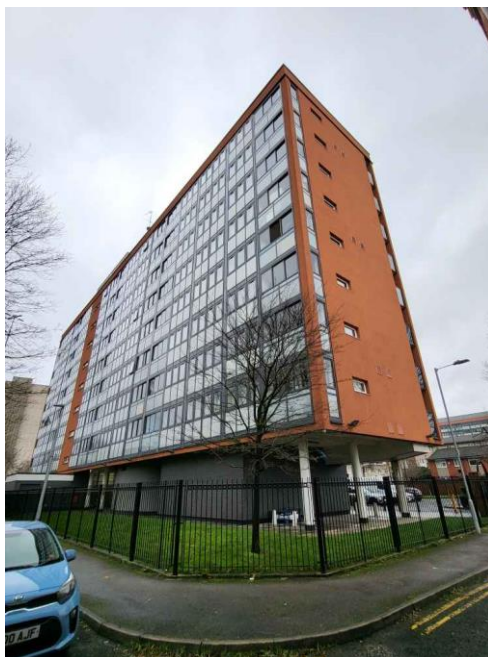
Figure 1 – Lamport Court

The building is approximately ~24m in height to the highest occupied floor, sitting in the ADB bracket of '5-18m', requiring, 90-minute element of structure fire resistance.

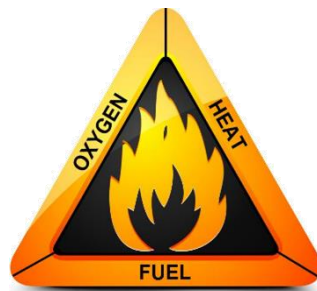
Figure 3. The Fire Triangle

Fire is an exothermic chemical reaction between a combustible material and oxygen. To sustain this reaction, oxygen, heat, and a source of fuel must be present, which gives rise to the concept of the fire triangle (Figure 3).

Without one of the three components of the fire triangle, a fire is not sustainable, and the reaction will terminate. This is the foundation of all fire-fighting concepts and procedures.

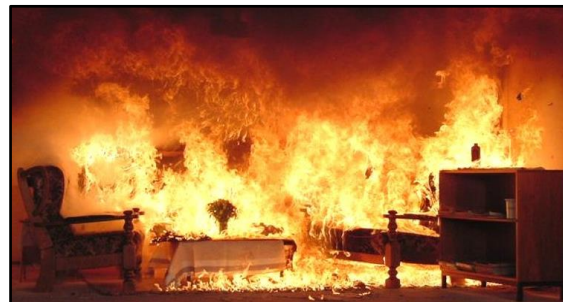
Figure 4. Fire caused by burning combustibles

The burning process (Figure 4) thermally decomposes the fuel source, producing volatile gases from the fuel surface. These volatiles mix with oxygen which results in combustion which generates heat. The additional heat produces more volatile gases and the process repeats.

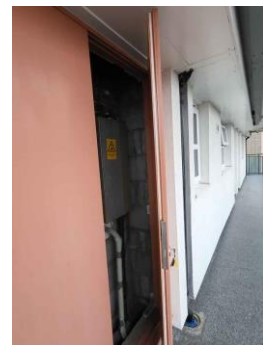
RISK 7 DESCRIPTION

There was no access to the boiler room. Other blocks show a pair of well maintained gas boilers.

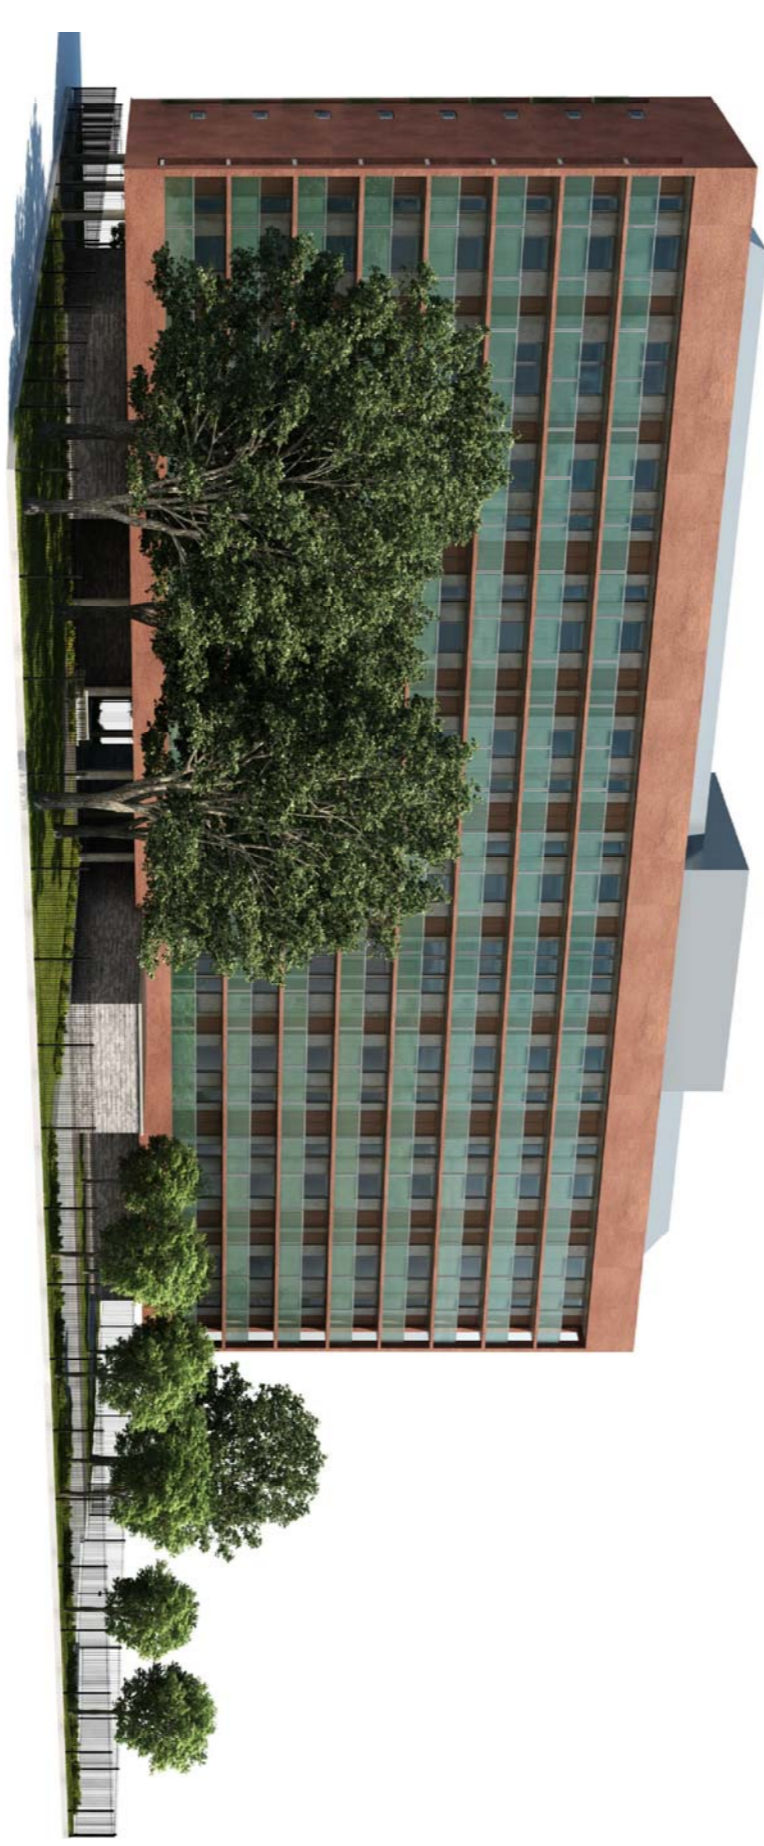
MODELLED FRONT ELEVATION

2 BEDROOM APARTMENT - DFA 2 COMPLIANT
CONVERSION OF 1 BED APARTMENT & STUDIO
(76.3sq.m/821sq.ft)

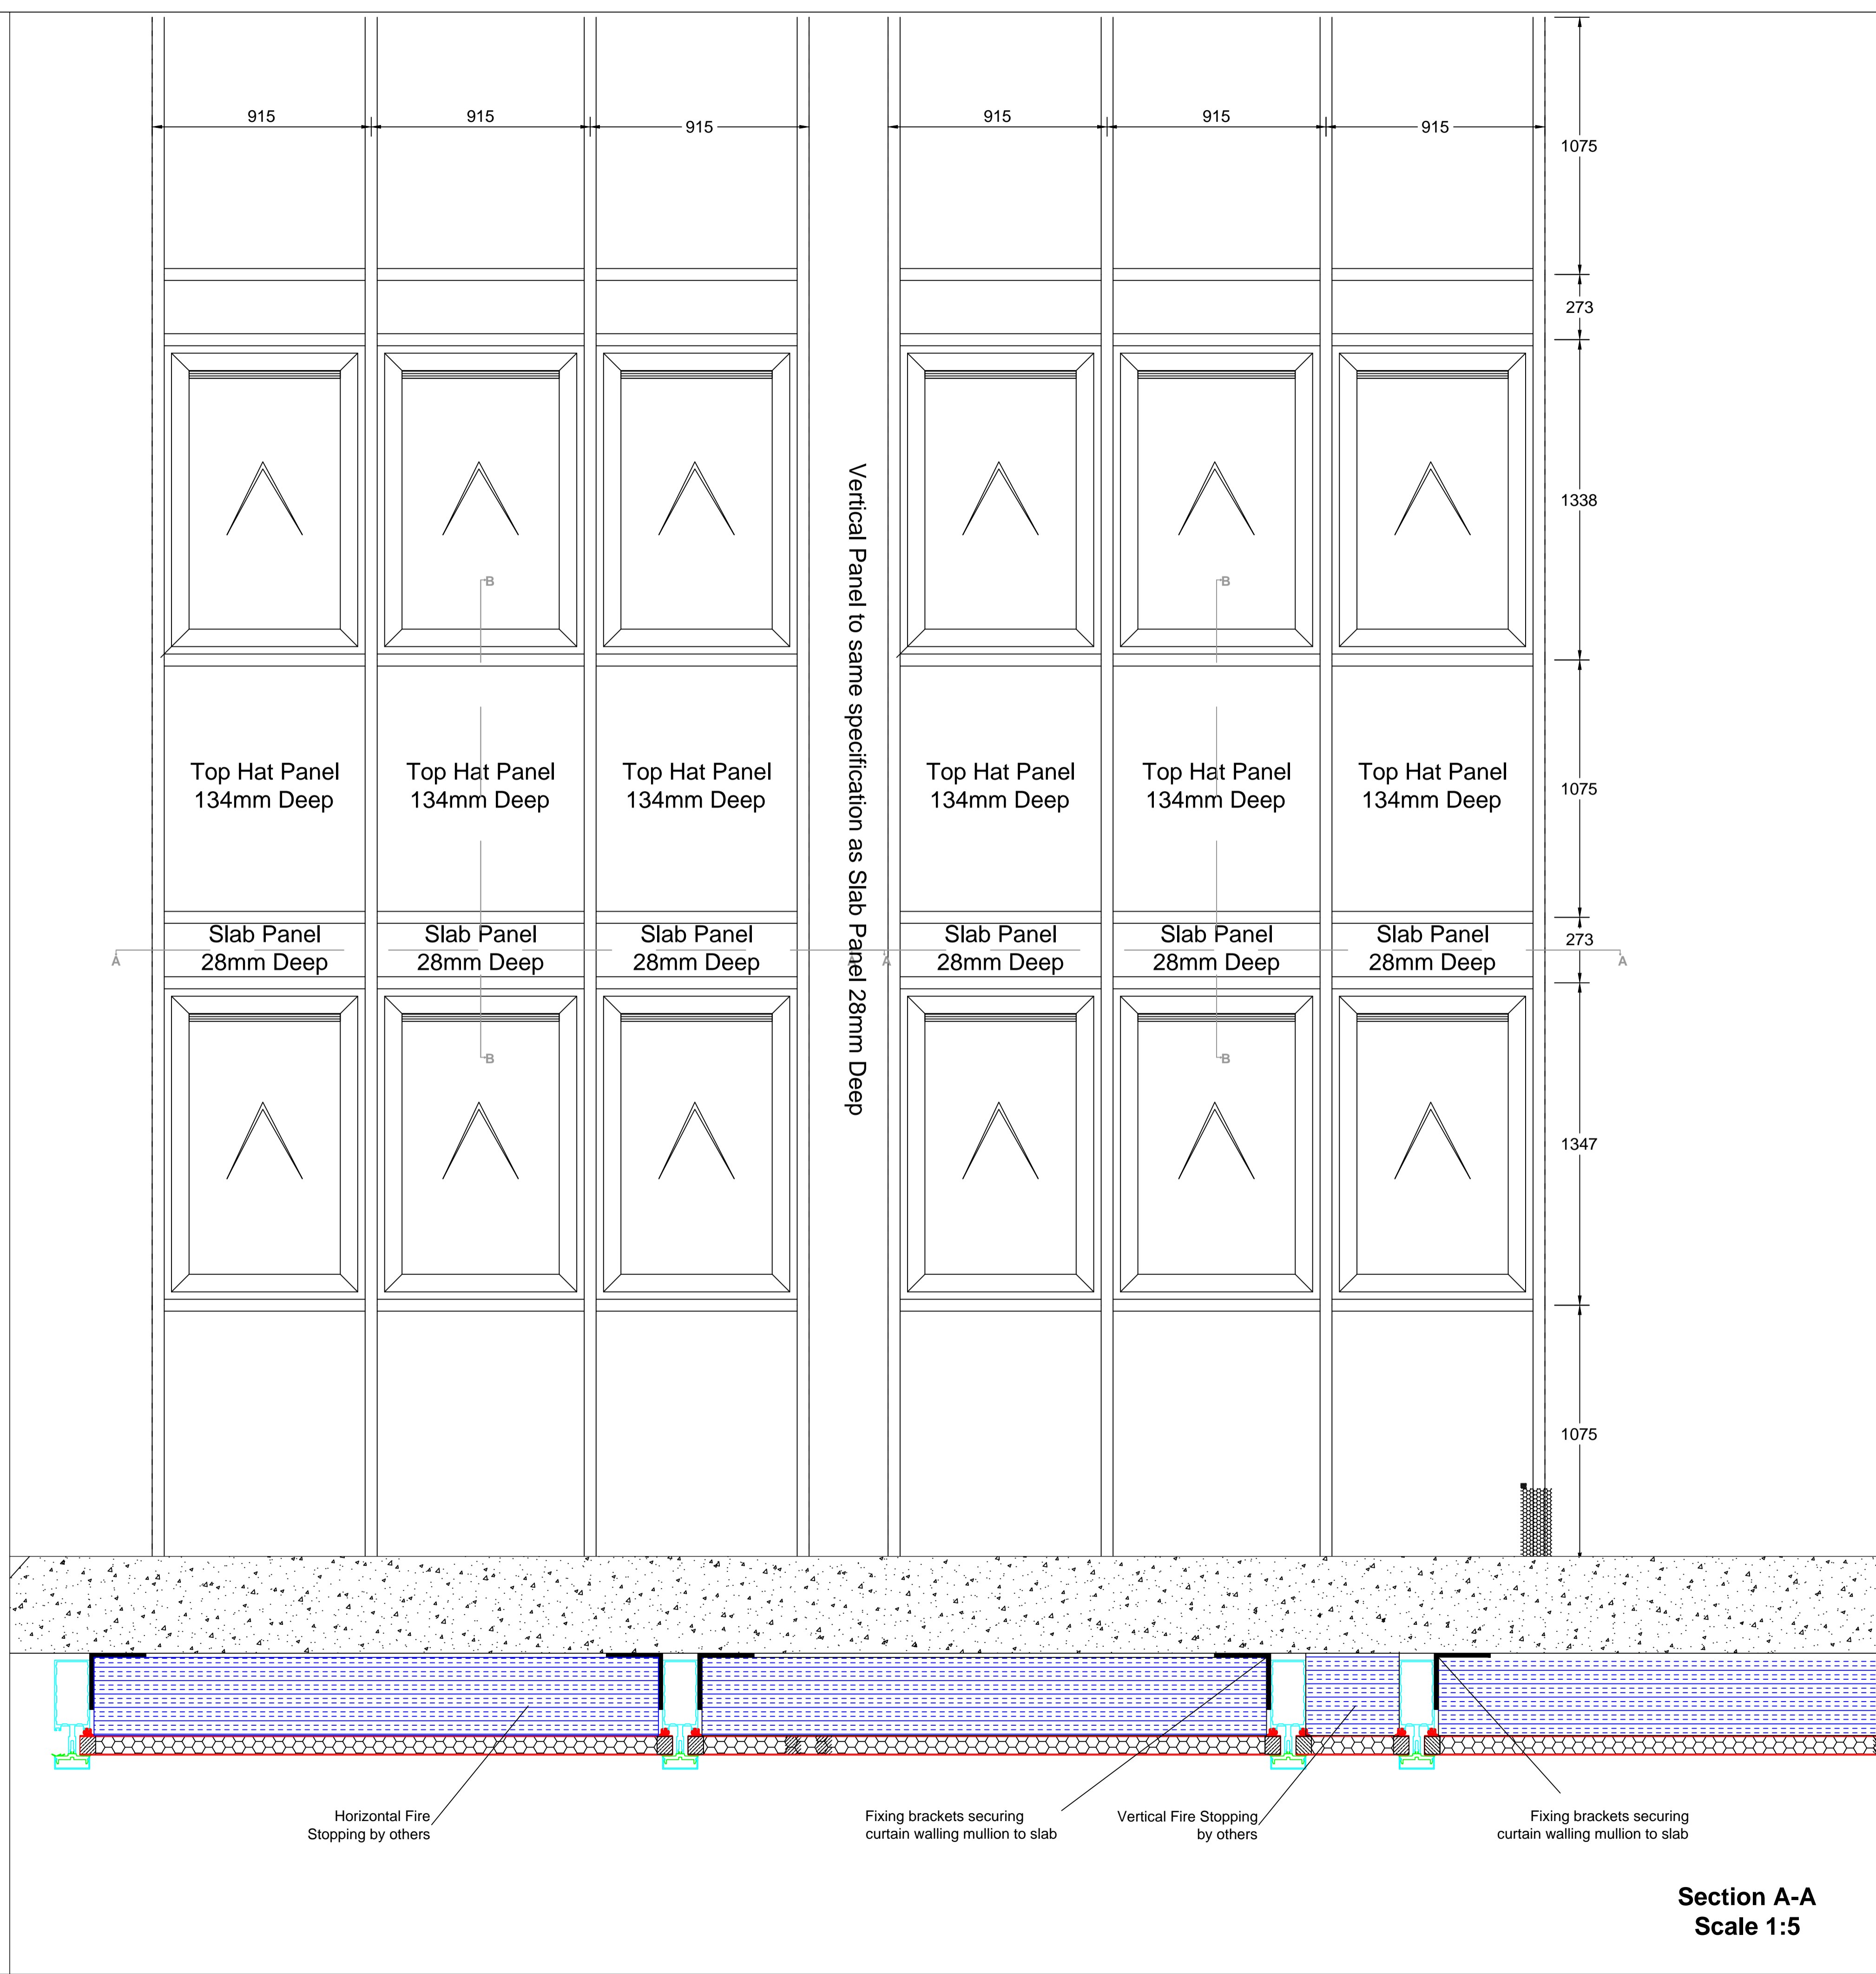
Section B-B
Scale 1:5

Panel Specification

- 1.5mm aluminium face PPC to match existing.
- Main Filling - Rock wool fab rock A1
- Perimeter edge filling - Rock Wool hard rock A1
- 1.5mm aluminium top hat mill finish
- Bonded with A8520 BLU SKY Spray adhesive and D2655 Green Polyurethane Adhesive

Section A-A
Scale 1:5

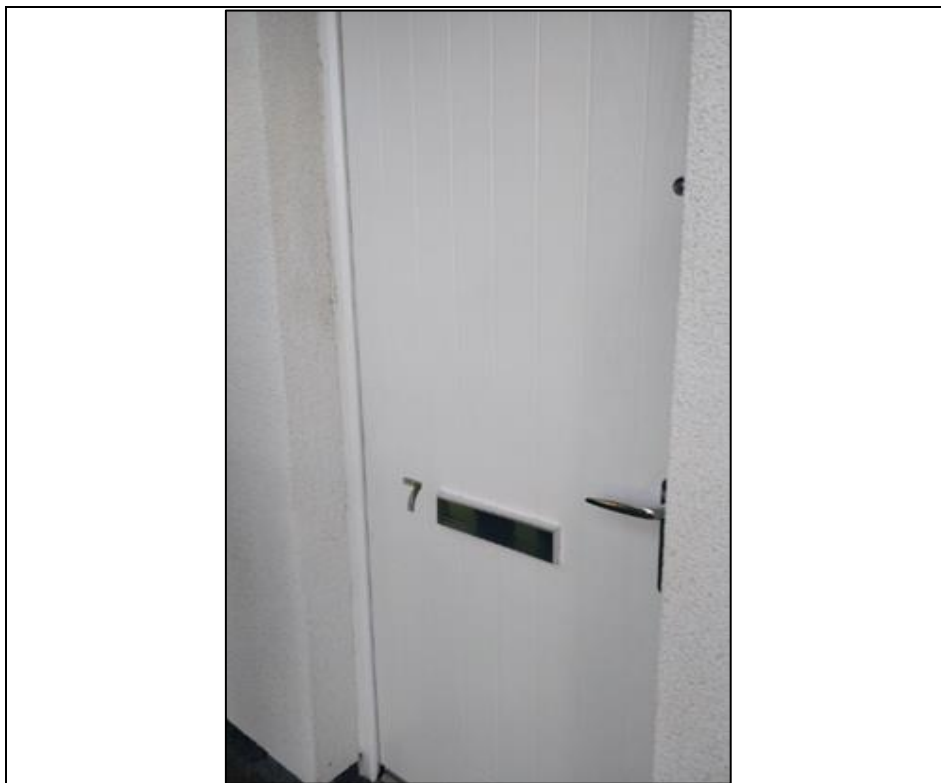
Figure 4- Photograph of door type B

- The furniture present on door type B (hinges, spyhole, intumescent strips, sleeved letterbox and handles) appears identical to that which is present in door type A (which was successfully tested and proved to have the requisite fire resistance).
- The hinges are marked with the IG doors stamp and marked as BS EN 1935 Grade 7.
- The letterbox in door type B is a Norseal Advantage Plus 60-minute fire rated letterbox with its own independent test evidence.
- The intumescent strips are Pyroplex graphite intumescent 15mm strips with their own independent test evidence.
- The door blank used in door type B has the same thickness (44mm) as door type A and by external examination appears to be constructed of the same or similar material as door type A.
- All type B doors have been stamped with BM Trada Q mark ink to the door leaf.

6.10 In order to definitively confirm door type B is a FD30S fire door it will be necessary to conduct a burn test in accordance BS476-22. Alternatively, the doors could be replaced with new FD30S certified fire doors.

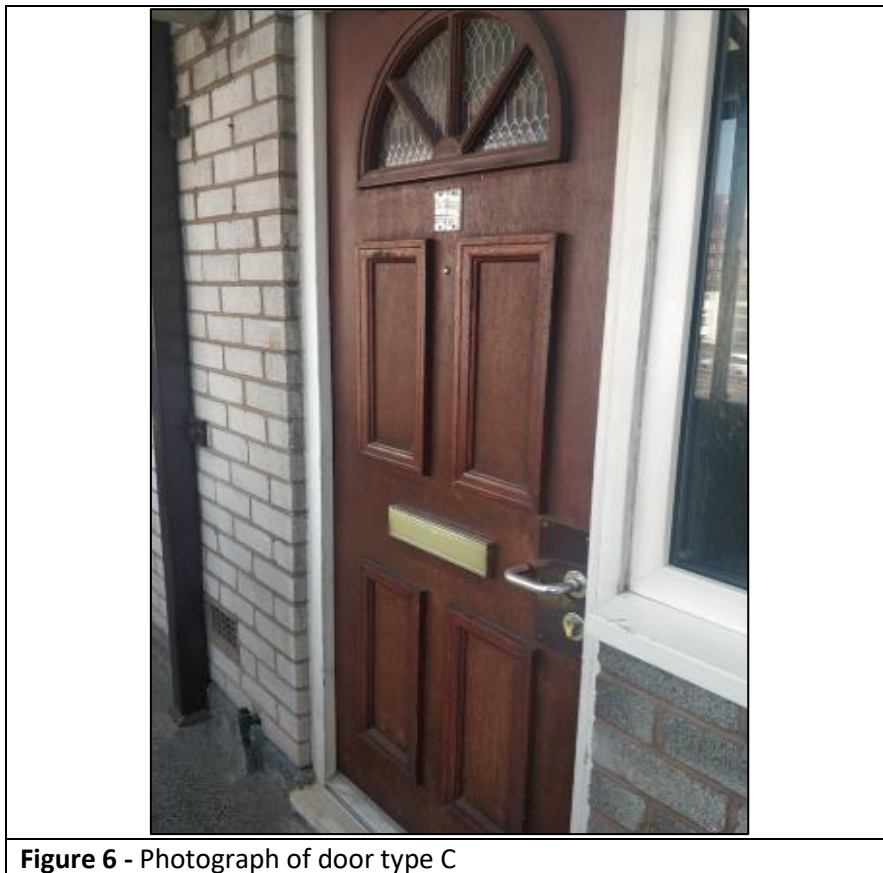
Figure 6 - Photograph of door type C

- 7.1 17 of the doors surveyed at Brunswick were identified as door type C. Door type C is a 4-panel timber door with 4 glazed panels forming a half moon at the top of the door. These doors have no IG markings and appear to have been in situ for many years prior to the works at Brunswick being carried out by Mears.
- 7.2 In light of the above, no information is available with regard to the supplier or the specification of these doorsets and therefore no opinion can be provided as to whether they are a fire door. A photograph of a door type C doorset is provided below.

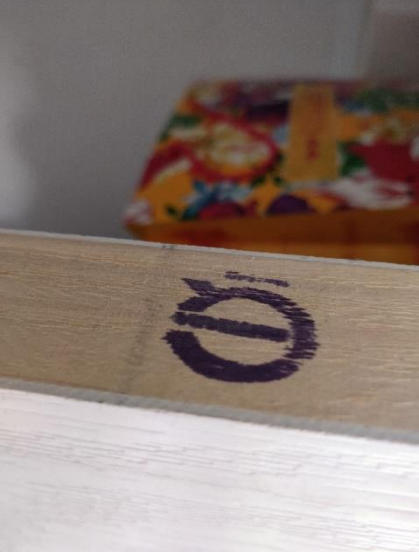
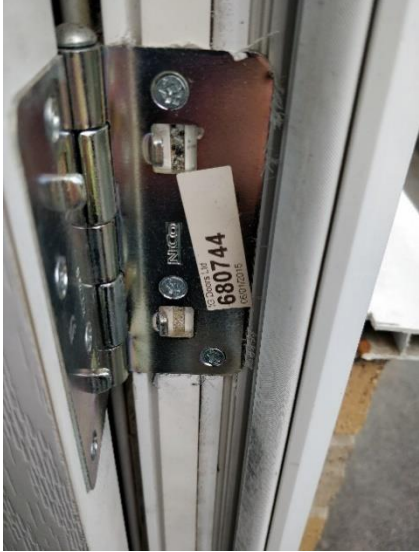
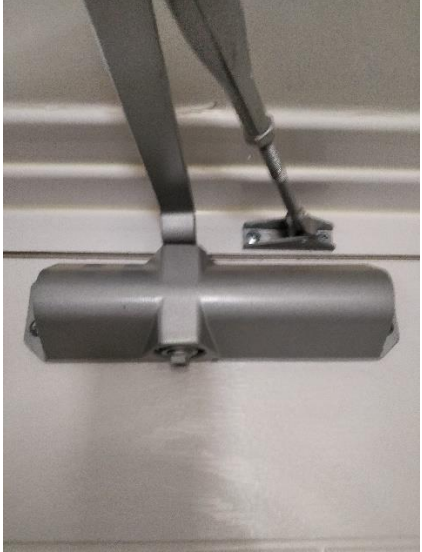
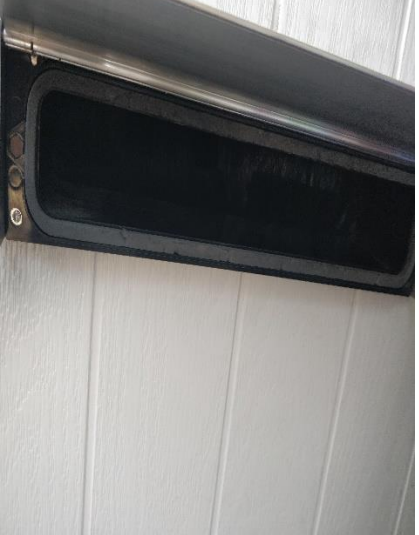
11.1 **Appendix 2** - Nominal door observations of door types B,D,E.

Q Mark Stamp	IG Hinges	Overhead Closer

Sleeved Letterbox
