Fire Risk Assessment

Property Owner: MCC
Date: 19/12/2023
Assessor: Stephen Brennan, TechIOSH, GFireE,
AIFSM, DipFD

Address: Lamport Court
Manchester
M1 7EG

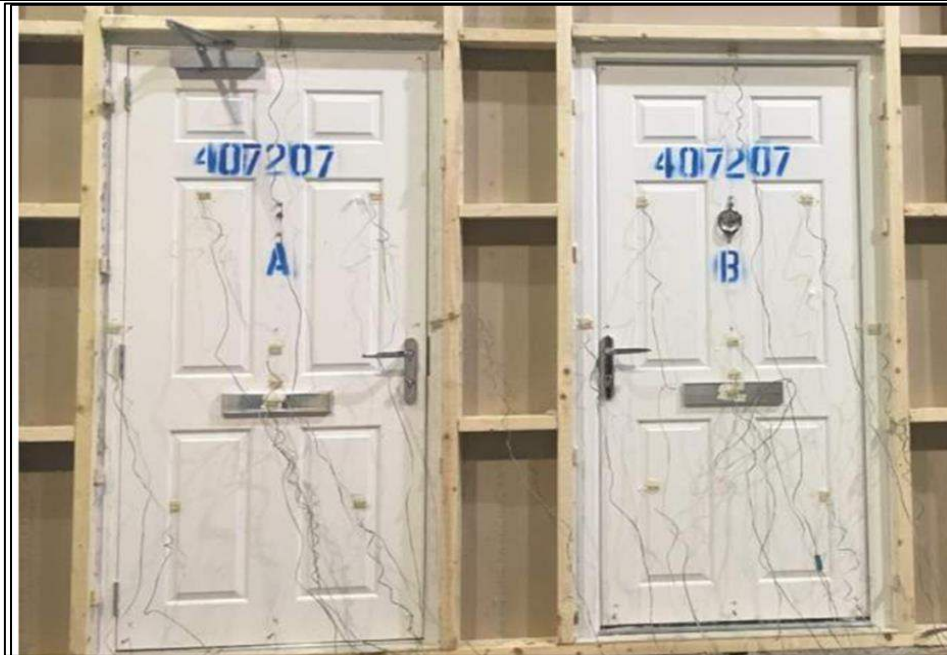
Figure 3 - Test Burn photographs

- 4.3 Appendix B provides further guidance as to the testing standards as follows: “The requirement (in either case) is for test exposure from each side of the door separately, except in the case of lift doors which are tested from the landing side only. Any test evidence used to substantiate the fire resistance rating of a door or shutter should be carefully checked to ensure that it adequately demonstrates compliance and is applicable to the adequately complete installed assembly. Small differences in detail (such as glazing apertures, intumescent strips, door frames and ironmongery etc,) may significantly affect the rating”.

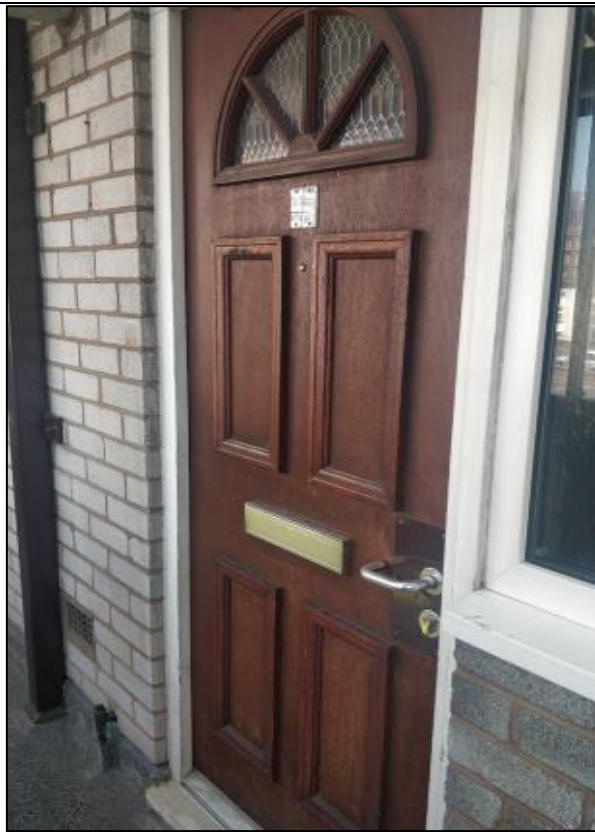
Figure 6 - Photograph of door type C

- 7.1 17 of the doors surveyed at Brunswick were identified as door type C. Door type C is a 4-panel timber door with 4 glazed panels forming a half moon at the top of the door. These doors have no IG markings and appear to have been in situ for many years prior to the works at Brunswick being carried out by Mears.
- 7.2 In light of the above, no information is available with regard to the supplier or the specification of these doorsets and therefore no opinion can be provided as to whether they are a fire door. A photograph of a door type C doorset is provided below.
