Fire Risk Assessment

Property Owner: MCC
Date: 19/12/2023
Assessor: Stephen Brennan, TechIOSH, GFireE,
AIFSM, DipFD

Address: Lockton Court
Manchester
M1 7JQ

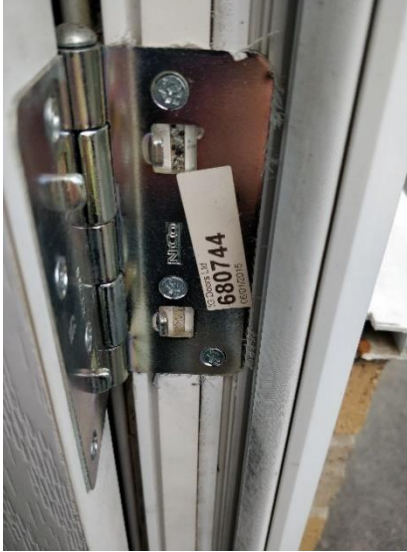
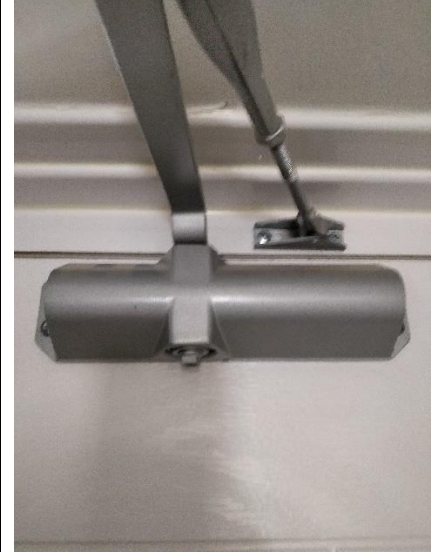
Q Mark Stamp	IG Hinges	Overhead Closer

11.1 **Appendix 2** - Nominal door observations of door types B,D,E.
